Keswick Stormwater Management Study

Class Environmental Assessment Project
File Report

14-09606-001-WR1

September 2010

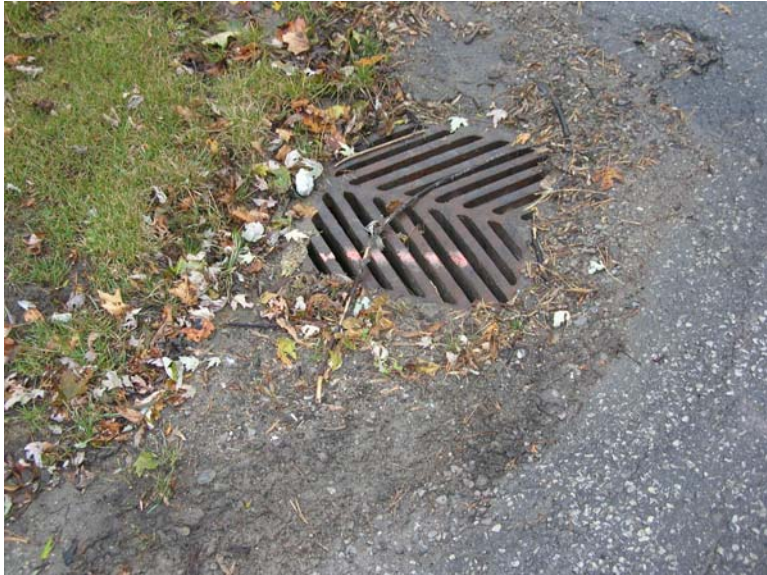
Photograph 1:
Typical Catch
Basin Inlet Lake
Drive North

These consist of a catch basin connected to a culvert (typically 450 mm in diameter) which traverses the road and discharges directly into Lake Simcoe. The only type of retrofit which would be applicable would be an oil-grit separator (OGS). In some

cases, it may be feasible to intercept two or more outfalls with a short length of storm sewer and provide a single OGS to treat several outfalls. Photographs 1 and 2 show examples. Many of these cases are located along Lake Drive North.

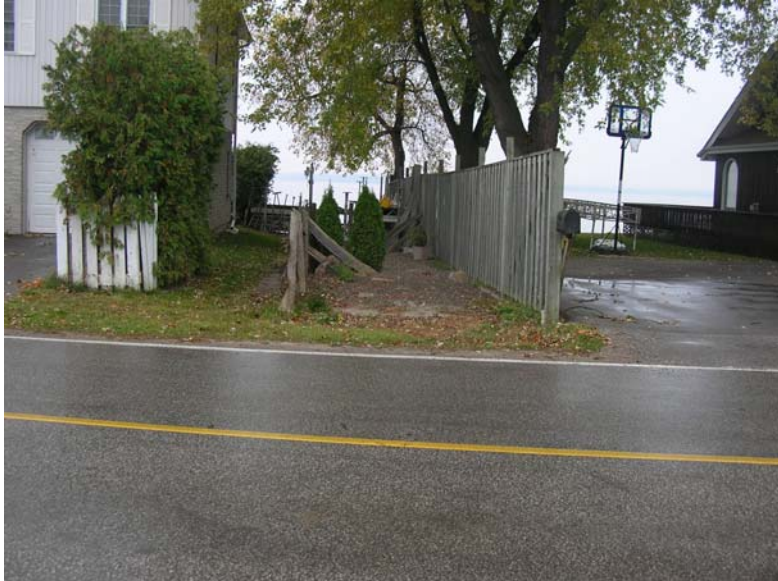
Photograph 2:
Typical Outfall
Location Lake
North Drive

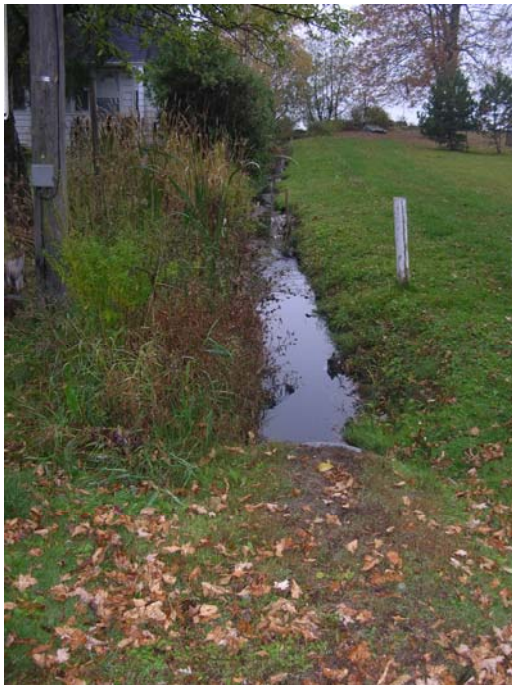
Photograph 3:

Typical Open Ditch Outfall

A large proportion of the existing outfalls consist of open ditches with either standing water or running water in them or swales with grass or bulrushes growing in them. In some cases, it may be feasible to improve these outlets by creating “Enhanced Swales.” This would involve widening them, modifying their slope and planting appropriate vegetation to promote settling of sediments. Issues that would have to be addressed would include: potentially negative effects on upstream drainage, compatibility with adjacent land uses, availability of space and private property rights. Photograph 3 shows a typical outfall of this type.

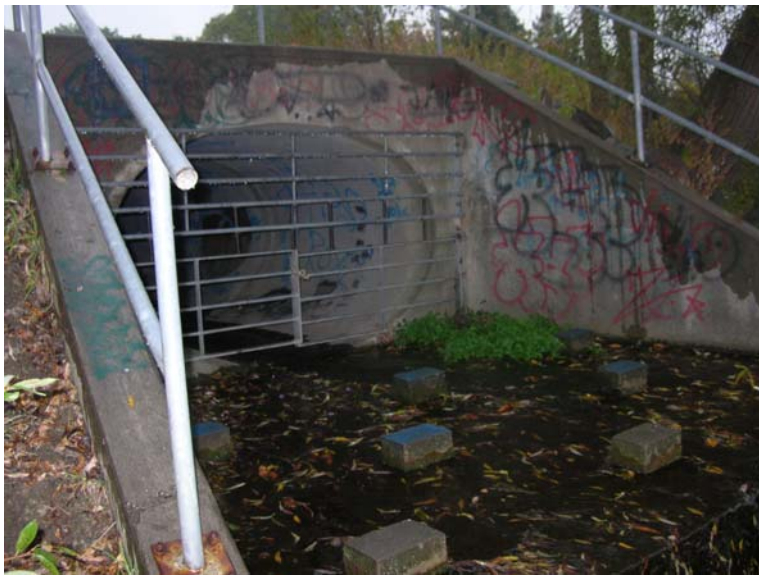
Photograph 4:
Major Storm Outfall

In a limited number of locations, there appear to be opportunities for a significant retrofit SWM facility to be constructed. These outfalls are generally located on or adjacent to property owned by the Town or other public agency. For example, a parking lot for a municipal park might afford the opportunity to construct some type of underground device such as a tank or filter to treat the parking lot runoff. Photographs 4 and 5 show an example of an outfall with a potential site nearby.

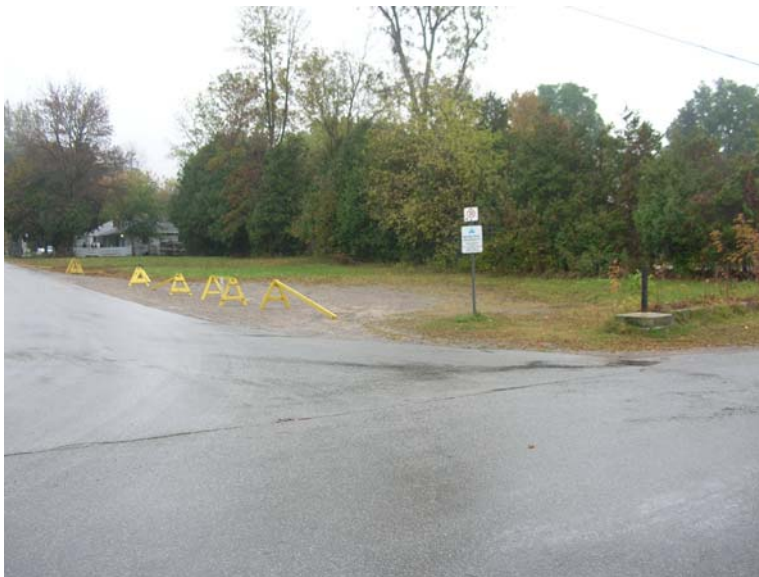
Photograph 5:
**Potential Site for
SWM Retrofit
Facility Adjacent to
Major Outfall**

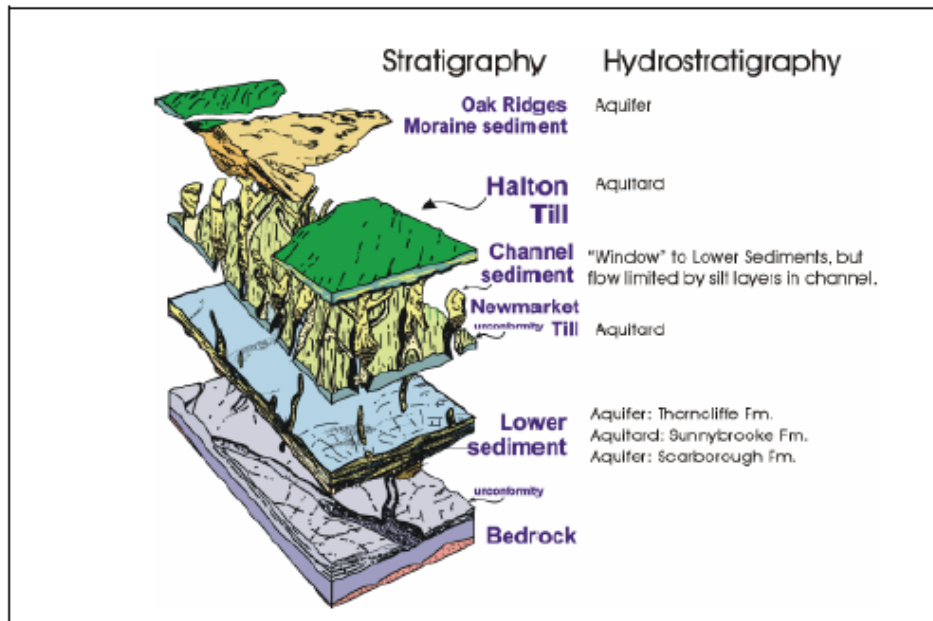
Figure 3.4.7
Geologic Survey of Canada Stratigraphic Framework in Oak Ridges Moraine Region

Figure 3.4.7 shows the stratigraphy of the layers and illustrates the aquifer and aquitard layers.
