MOSSINGTON BRIDGE

FINAL REPORT

TECHNICAL REVIEW

Town of Georgina

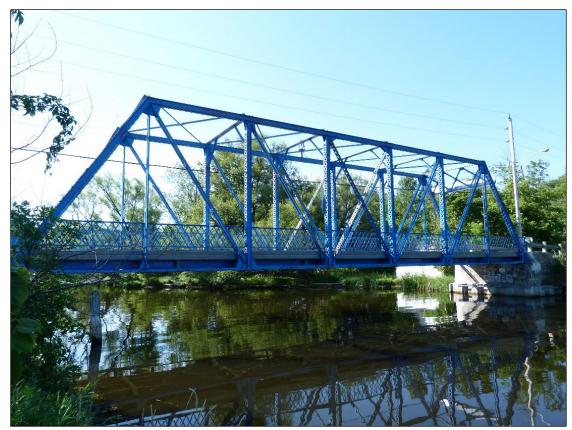
Figure 2: Mossington Bridge

The bridge is a single-span through-truss bridge, with vertical and diagonal trusses. The bridge is 28.6 meters in length and has a 150-millimetre concrete deck and is 3.8 meters in width. There are also 1-metre latticed handrails along each side of the bridge. At present, there is no load restriction.

The Mossington Bridge is shown in Figure 2.

The existing bridge, which was built about 1912, consists of 28.1 +/- m single span structural steelthrough trusses with a 150 +/- mm concrete deck with asphalt patches. The concrete deck is supported by four (4) lines of longitudinal structural steel stringers at 1.45+/- m centres and provide a 3.83+/- m wide deck between curbs, which accommodate a single lane of vehicular traffic. Structural steel latticed handrails are located inside the trusses. The bridge is posted with a 10-ton load limit.

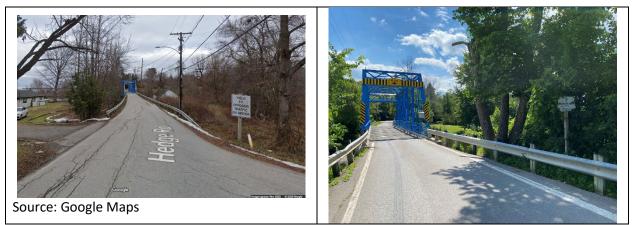
Figure 3: Approaches to Mossington Bridge

The east approach generally curves to the left but maintains sufficient sight distance to see a vehicle approaching from the west for a posted speed limit of 30 km/h. The west approach is generally straight and has sufficient sight distance to see approaching vehicles. Both sides also have "Yield to Opposing Traffic on Bridge" signage, as shown in **Figure 3**.

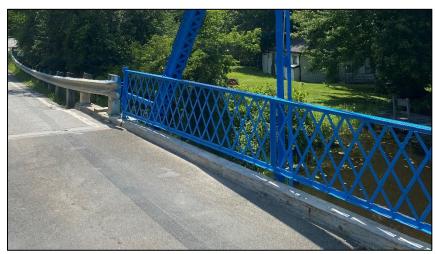
Figure 4: Latticed Handrail

A field visit was conducted by SRE and Town Staff on July 7, 2022, to observe the site area and determine potential areas of concern that could be addressed throughout this project. The latticed handrails run along the entire length of the bridge at a height of 1-metre. The height of the rails is at a level that is easy to jump over, and the lattice within the handrails provides footholds to climb the railing. A section of the handrails is shown in Figure 4.

The installation of a clear acrylic and polycarbonate safety barrier along the inside of the bridge will prevent individuals from using the latticed handrails as footholds. The clear nature of the acrylic and polycarbonate panels will not bring attention to this mitigation strategy. A sample of this treatment is provided in **Figure 7**.

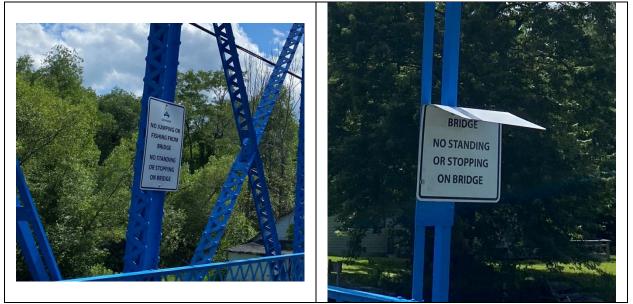
Figure 5: Posted Signage on Mossington Bridge

• Signage to deter people form approaching or jumping from the bridge, as seen in Figure 5

At present, there is no signage specifically indicating the dangers of jumping off the bridge. Highlighting this information, in attention grabbing colours, at the bridge location would educate people at the bridge itself.

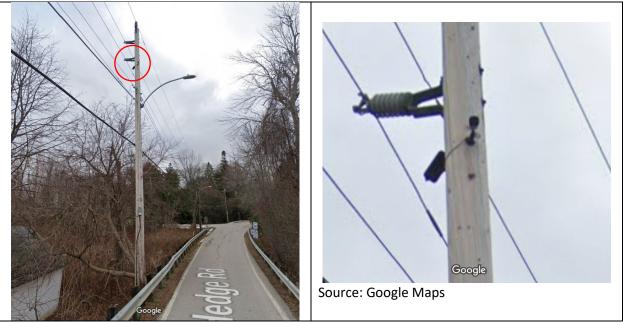
Figure 6: Mounted Camera for Mossington Bridge Surveillance

• Camera mounted surveillance of the bridge to deter undesirable actors, as shown in Figure 6

At present, there are inconspicuous cameras monitoring the Mossington Bridge. Bringing attention to security cameras, by enlarging the cameras and providing signage highlighting that cameras are monitoring the bridge will discourage people from jumping off the bridge. The infrastructure is generally in place as there are cameras currently at the Mossington Bridge.
