# Mossington Bridge Modifications

Prepared for the Town of Georgina  
Prepared by Doug Dixon & Associates Inc.

April 2024

<b>MOSSINGTON BRIDGE MODIFICATIONS</b>	
<b>LOCALIZED PLATE DETAILS TO DETER CLIMBING</b>

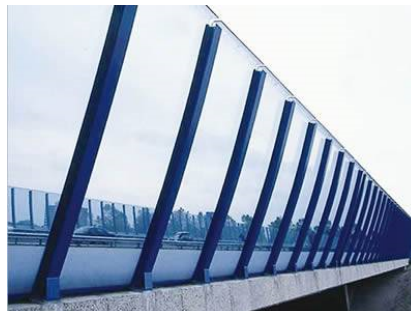
Figure 1 – Acrylic barrier on the parapet of a bridge.

The acrylic barrier would be affixed to the railing and additional framing steel on the traffic side of the bridge at a height that people could not reach over. There would also be an additional acrylic barrier required on the exterior of the bridge as individuals could access the truss members from the abutments and bottom chords.

There are a number of disadvantages to using acrylic panelling. Given the small reserve load carrying capacity of the existing bridge (found in the 2015 Jewell Report), we believe the existing bridge is not able to carry the dead load from the acrylic panels combined with the large increase in lateral load from the wind loading on the panels.

To support the panels, additional steel framing will also be required, which will increase the dead load added to the bridge.

In addition, the panels are prone to graffiti as well as discolouration due to exposure to ultraviolet sunlight. Other methods can also be used by vandals to scratch or otherwise mark the surface of the acrylic panels. Wind blown debris/dust will also etch the acrylic panels.

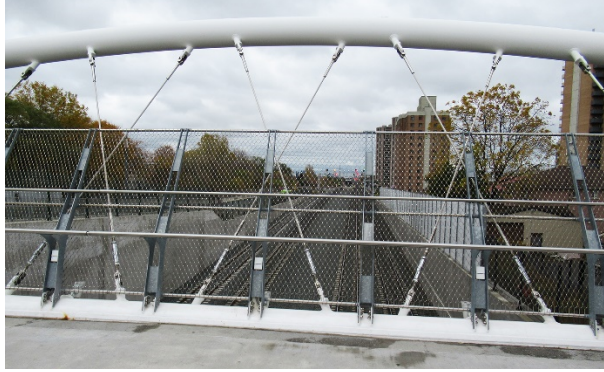
Figure 2 – Localized fencing around structural members

The second alternative is similar to the first in methodology but varies in material. Instead of an acrylic barrier, a net / mesh / fence barrier system would be implemented on the traffic side of the bridge between the roadway and the trusses. This is depicted in Figure 2.

The net / mesh / fence would be affixed by a similar auxiliary steel framing system as the acrylic panels.

As with the acrylic barrier, to be fully effective, a second barrier would be required on the exterior of the truss; thereby “sandwiching” the truss members between two (2) layers of mesh/fence.

In addition, the lateral wind load on a chain link fence (or similar mesh) would be very similar to that for an acrylic panel. Ice accretion must be considered on the mesh. Ice accretion in the Town of Georgina area is such that the mesh must be considered as approximately 70% solid. This puts substantial lateral wind load on the bridge which it is not currently designed for.

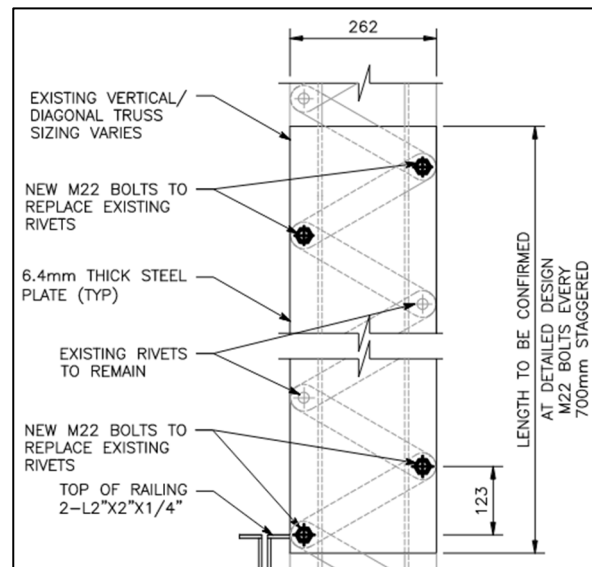
Figure 3 – Concept of localized plates added to the members prone to climbing.

The third alternative involves the addition of 6.4mm ( $\frac{1}{4}$ " ) thick steel plates locally otop of the existing lacing bars on each vertical and the central diagonal members composed of built up members. This is shown in Figure 3 below. The plates would be placed strategically to provide an impediment to climbing the lattice bars on the built-up members.

Localized additional steel plating to cover the existing lacing bars and thereby deterring using the lacing bars as “ladder rungs” is one of the alternatives considered by DDA.

This alternative would add little additional deck load to the bridge with almost no perceivable increase in wind loading.

The steel plates and bolts are “heritage” compatible with the steel in the bridge in DDA’s opinion. The proposed plating of portions of the verticals and midspan diagonal truss members is similar to reinforcing of steel members that has been completed in the recent rehabilitation.
