Hedge Road Bank Stabilization – Public Information Centre
Town of Georgina

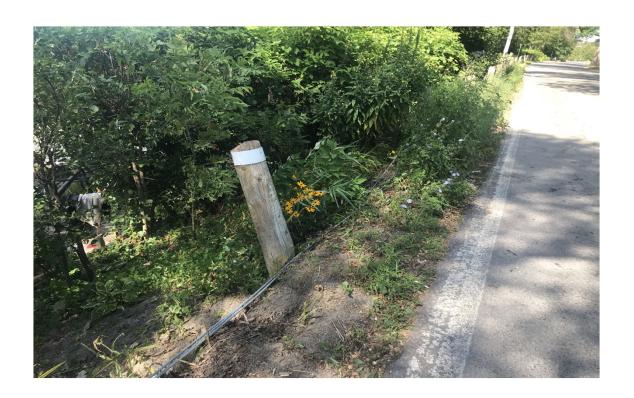
- Hedge Road between the Black River and 200 m east of Seaward Drive has a steeply sloped bank to Lake Simcoe
- In recent years, the bank has experienced erosion events that put the integrity of road infrastructure at risk and needed localized repair

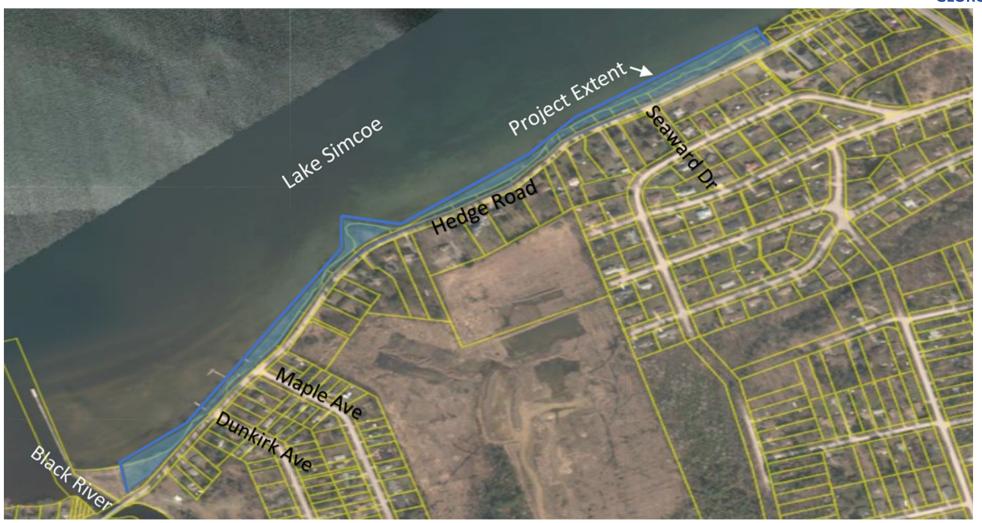
What is the Study Area?

Total shoreline/road length of 1100 m.

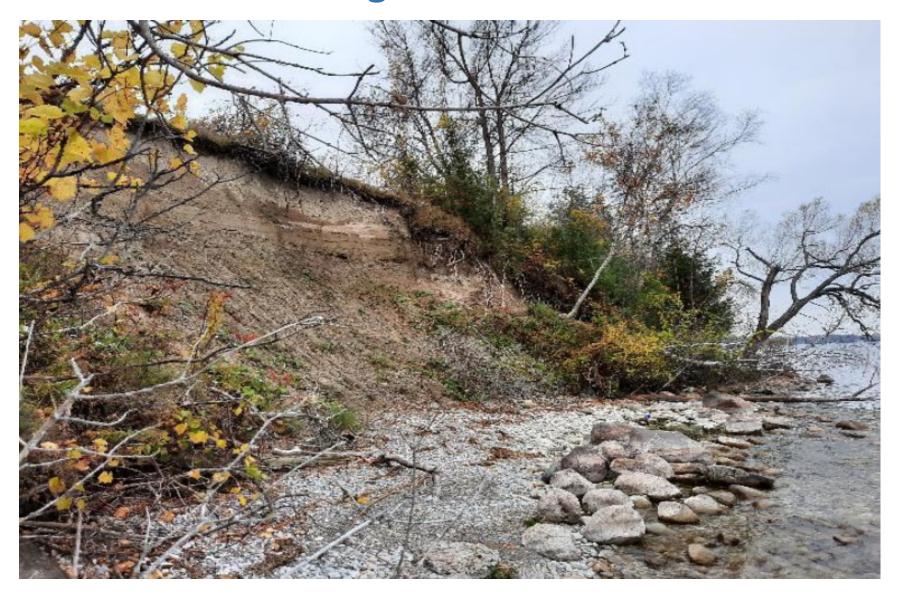
Significant erosion along east end of study area near Seaward Drive (across from 363 Hedge Road), where bank is highest.

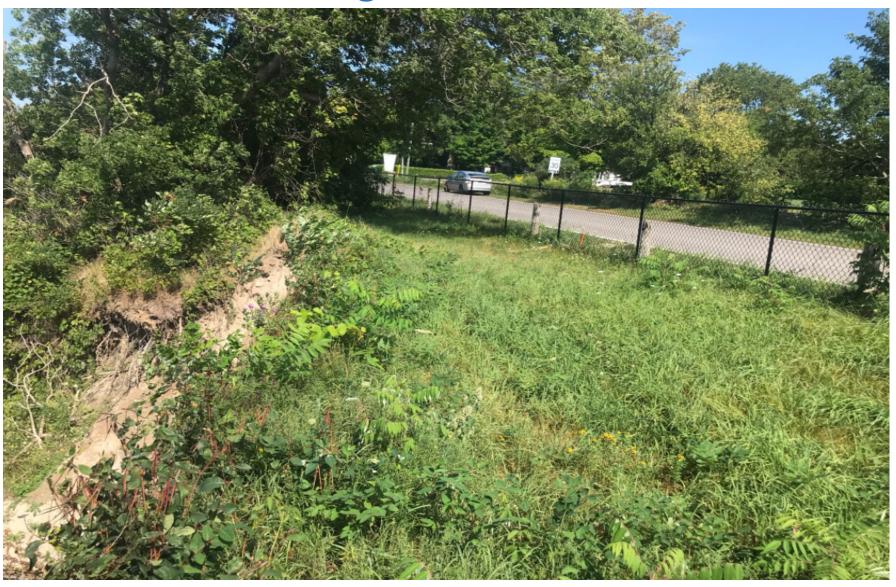
Potential for erosion to affect road if left unprotected

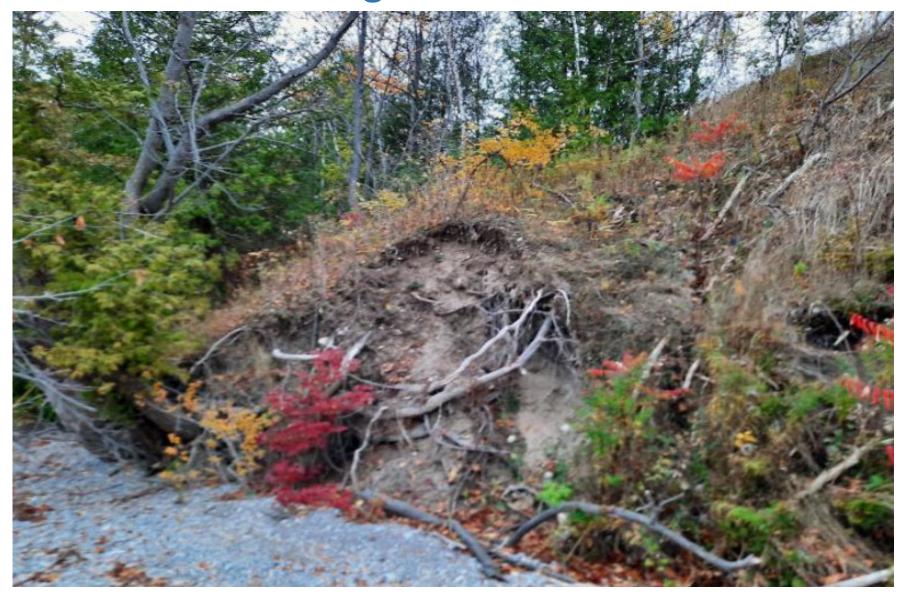
Moving west from Seaward Drive, extent of active erosion is smaller but areas of erosion at the toe of the slope are evident

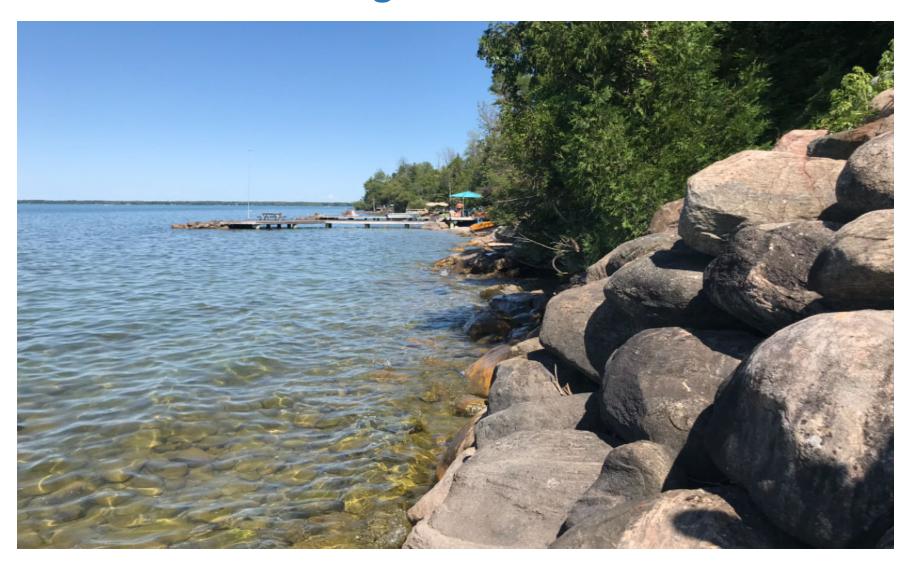
Moving westerly towards the horn, there are several areas where erosion repairs have been necessary. Repair works include large boulder revetments (installation across from 317 Hedge Road shown) and a section of sheet pile wall.

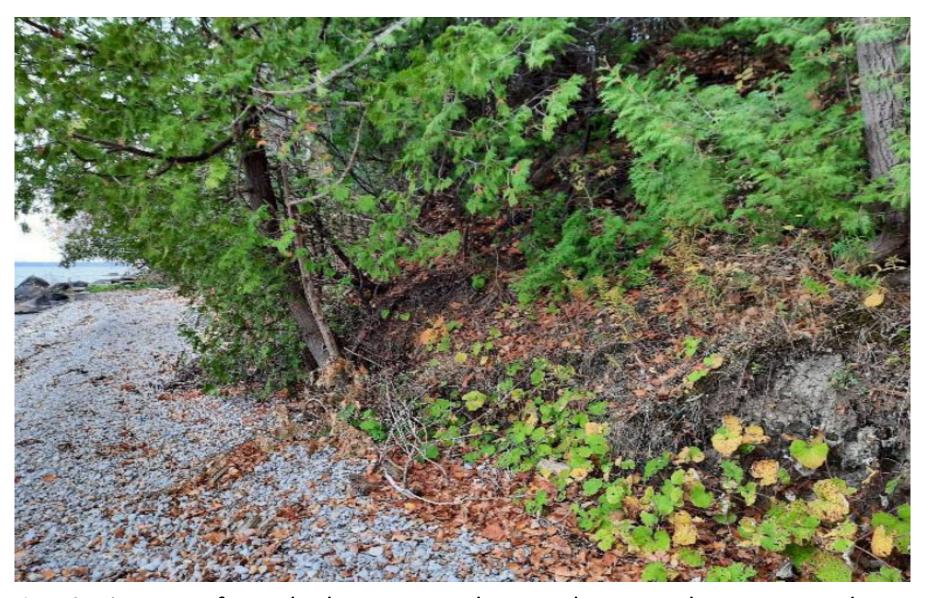
Continuing west from the horn to Maple Ave, slopes are less steep and only localized minor erosion was seen (near 299 Hedge Road).

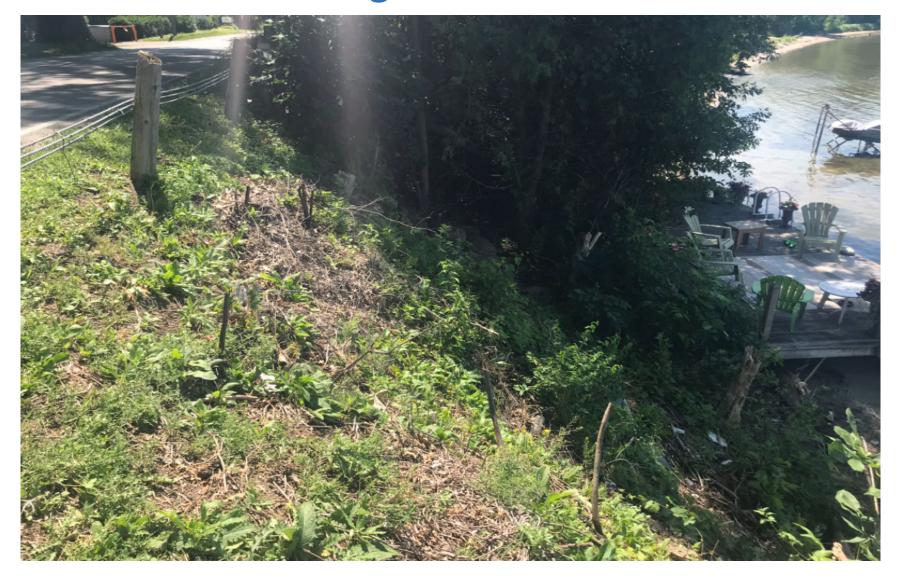
Towards the west end, the edge of the road is very close to the top of bank and there are areas that have been cleared of vegetation, making them more prone to erosion (photo approx. 20 m west of Dunkirk Ave)

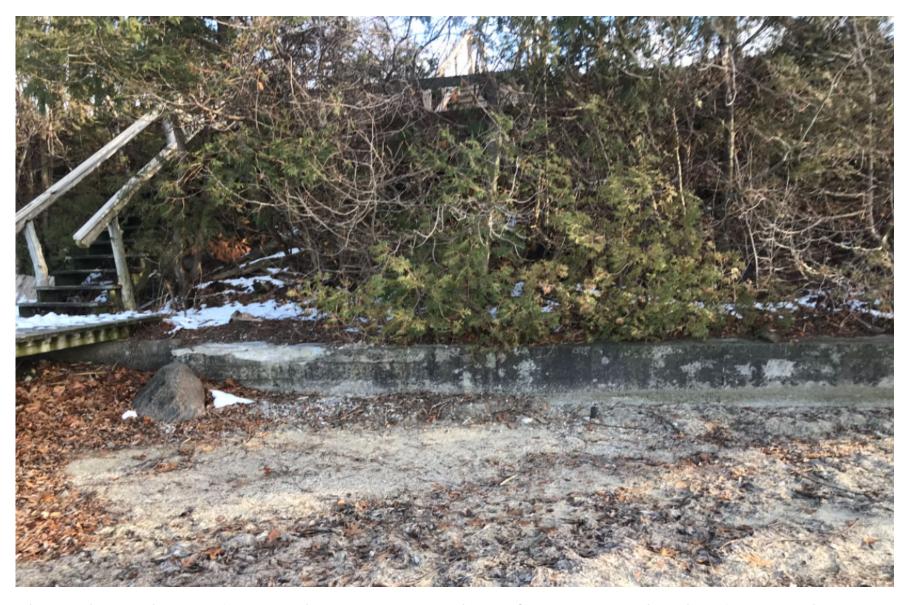
Throughout the study area there are a number of structures that landowners have constructed. These include stairs to access the shoreline, decks, docks & retaining walls

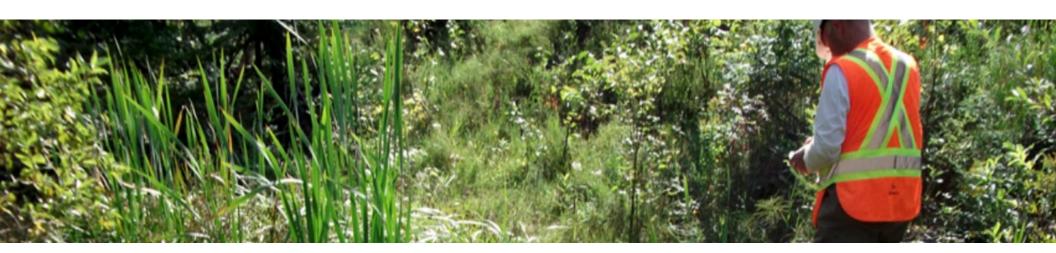
Existing conditions were assessed in the following ways:

- 33 sections were analyzed
- Coastal modelling to predict wave conditions and flood hazard
- Geotechnical study to determine slope stability
- Calculation of erosion hazard how far could the bank erode if left unprotected
- Results show road requires protection through most of the study area

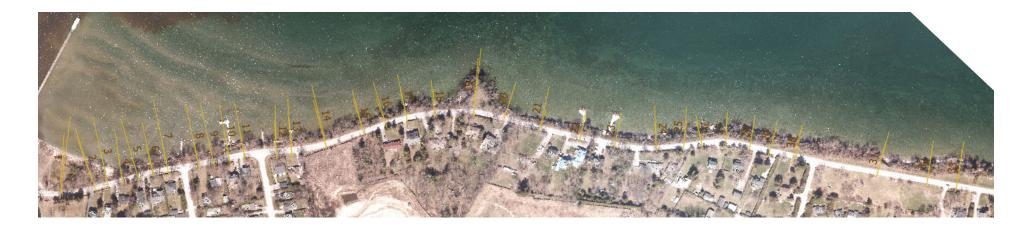
Design Analysis – Erosion Hazard

Erosion hazard limit considers how far erosion could progress over time

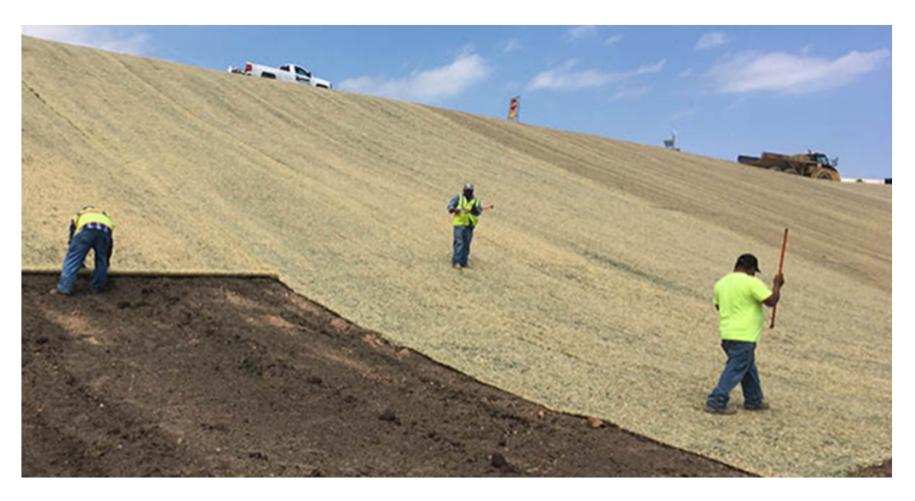
Alternatives – Erosion Control Blanket

- For areas with limited vegetation, erosion control blankets, which are laid on the ground and staked in place can provide erosion protection to bare soil while vegetation is being established
- Erosion control blankets can be made of biodegradable natural materials or synthetic material

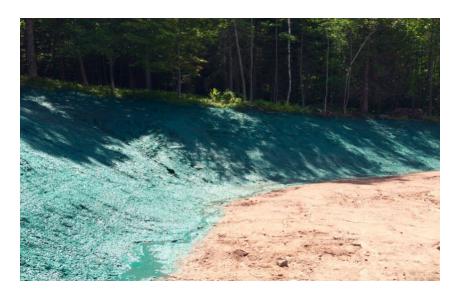
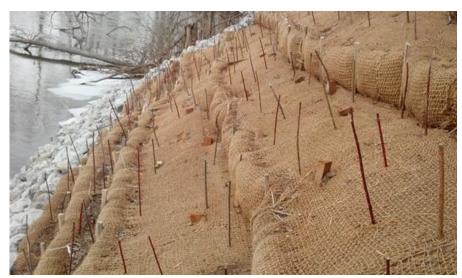
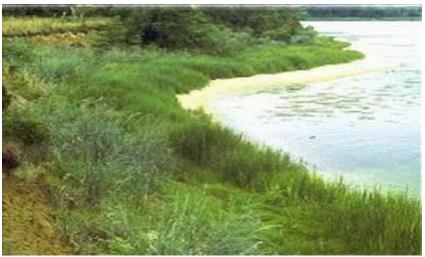
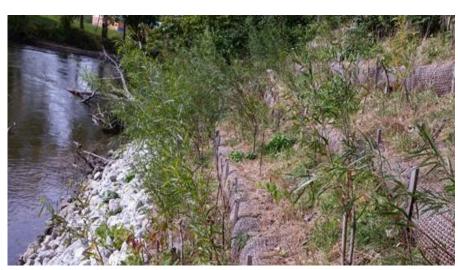
Alternatives – Vegetation Enhancement

For areas with insufficient vegetation, enhancement though seeding (left), live stake plantings (right) and other planting strategies can improve slope stability

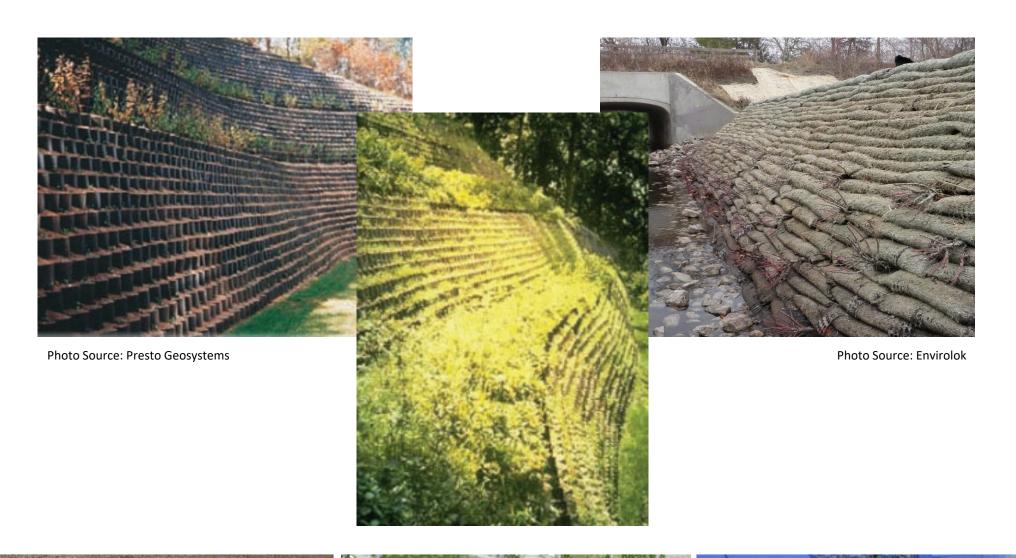
Alternative – Green Retaining Wall

Green retaining wall systems use synthetic soil containment cells (usually grids or soil bags) to stabilize the slope and promote vegetation growth.

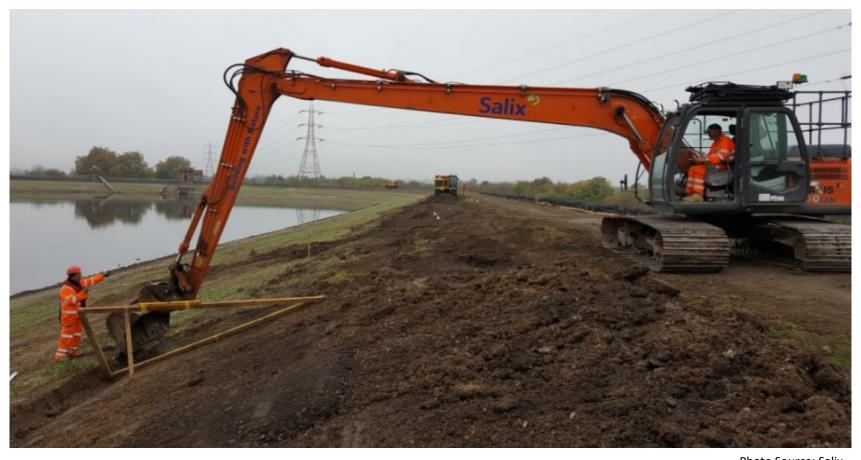
Alternatives – Slope Regrading

- If the slope can be extended at the toe or top of bank, the slope can be made flatter, and therefore more stable, through grading works
- This requires clearing all vegetation for construction purposes
- Hedge Road does not have space available for this alternative to be feasible

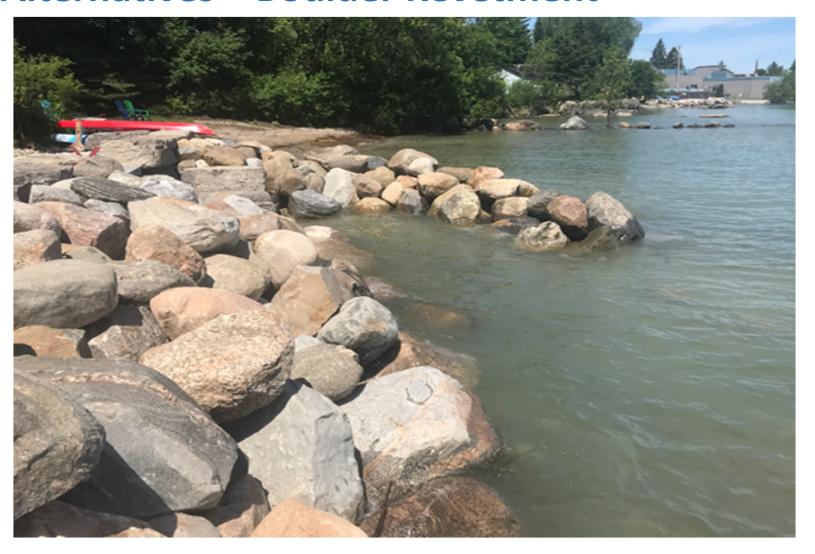
Alternatives – Boulder Revetment

- Boulder revetments involve placement of stone against a slope to protect against erosion from waves
- They are preferred over vertical retaining walls as they absorb wave energy and provide more habitat opportunity than hardened walls

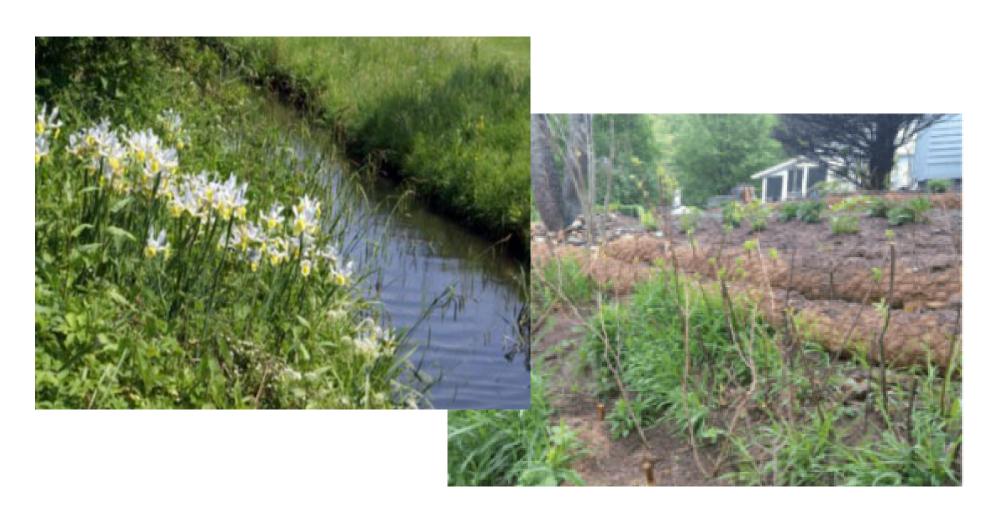
Recommended Alternative – Upslope Protection

Erosion control blanket and/or vegetation enhancement for localized areas with active erosion or sparse vegetation

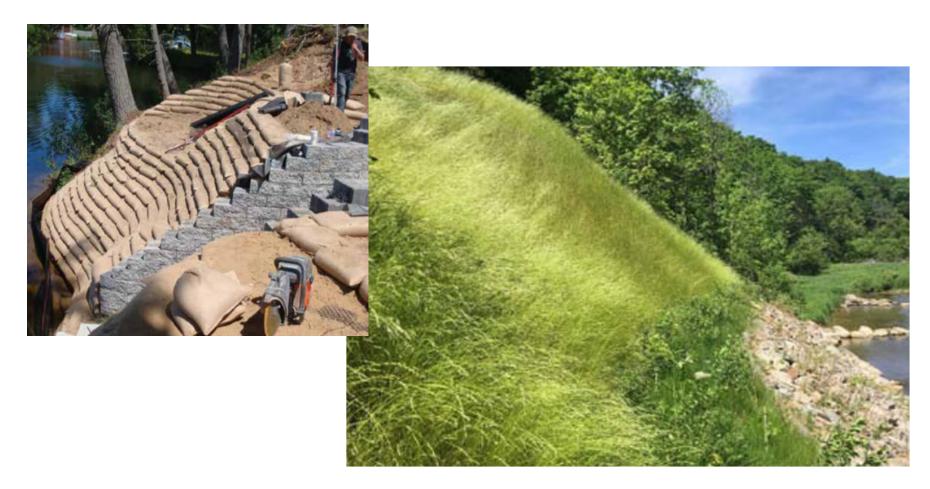
Recommended Alternative – Green Retaining Wall

For the slope failure area at the eastern project limit, more extensive measures are required given the bank height and extent of erosion. A green retaining wall, using soil bags, is recommended

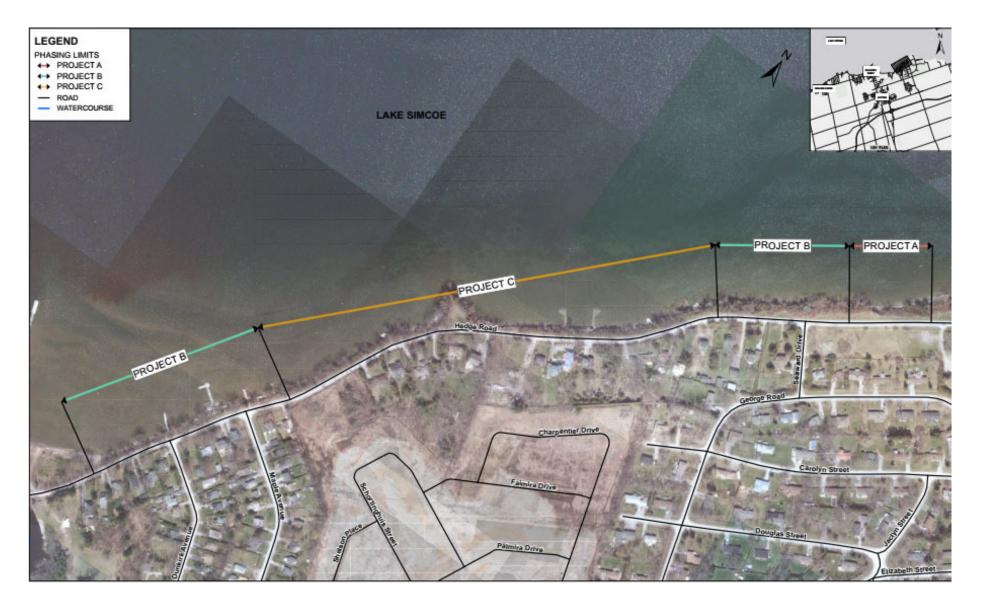
Project Implementation

3 Projects were defined (Projects A, B and C) based on erosion risk

PROJECT	APPROX. LENGTH OF SHORELINE PROTECTED	RECOMMENDED TIMELINE FOR CONSTRUCTION	DESCRIPTION OF WORKS
A	105 m	Near Term	Green Retaining Wall and Boulder Revetment
В	335 m	Mid Term	Boulder Revetment, Erosion Control Blanket and Revegetation in Selected Areas
C	240 m	Longer Term	Boulder Revetment, Erosion Control Blanket and Revegetation in Selected Areas
